Chain Replacement

Removing Chains

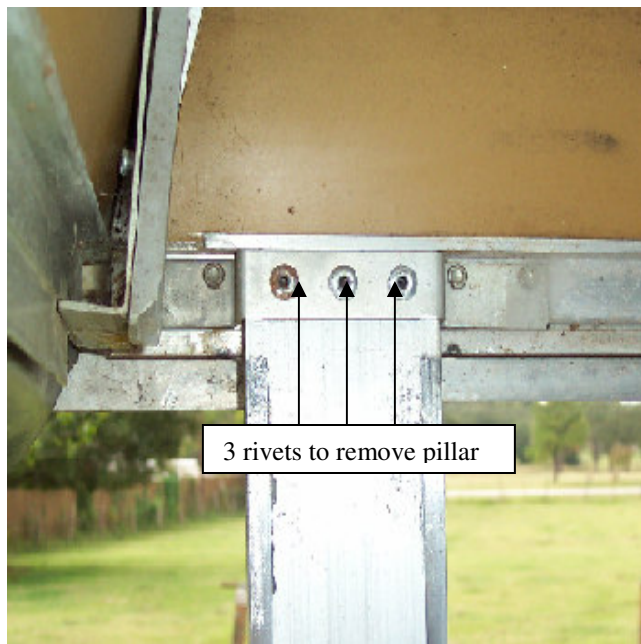
Drill out the 3 pop rivets at the top of the telescope extrusion. I have had good success with using a drill larger than the center of the rivet, which cuts off the outer flange allowing the removal of the rivet. In the liftsys.pdf file look on the manual's page 5 <- printed on the page. (Page 7 of Acrobat page counter). The pop rivets look like 3 black dots

This picture shows the placement of the 3 rivets in question.

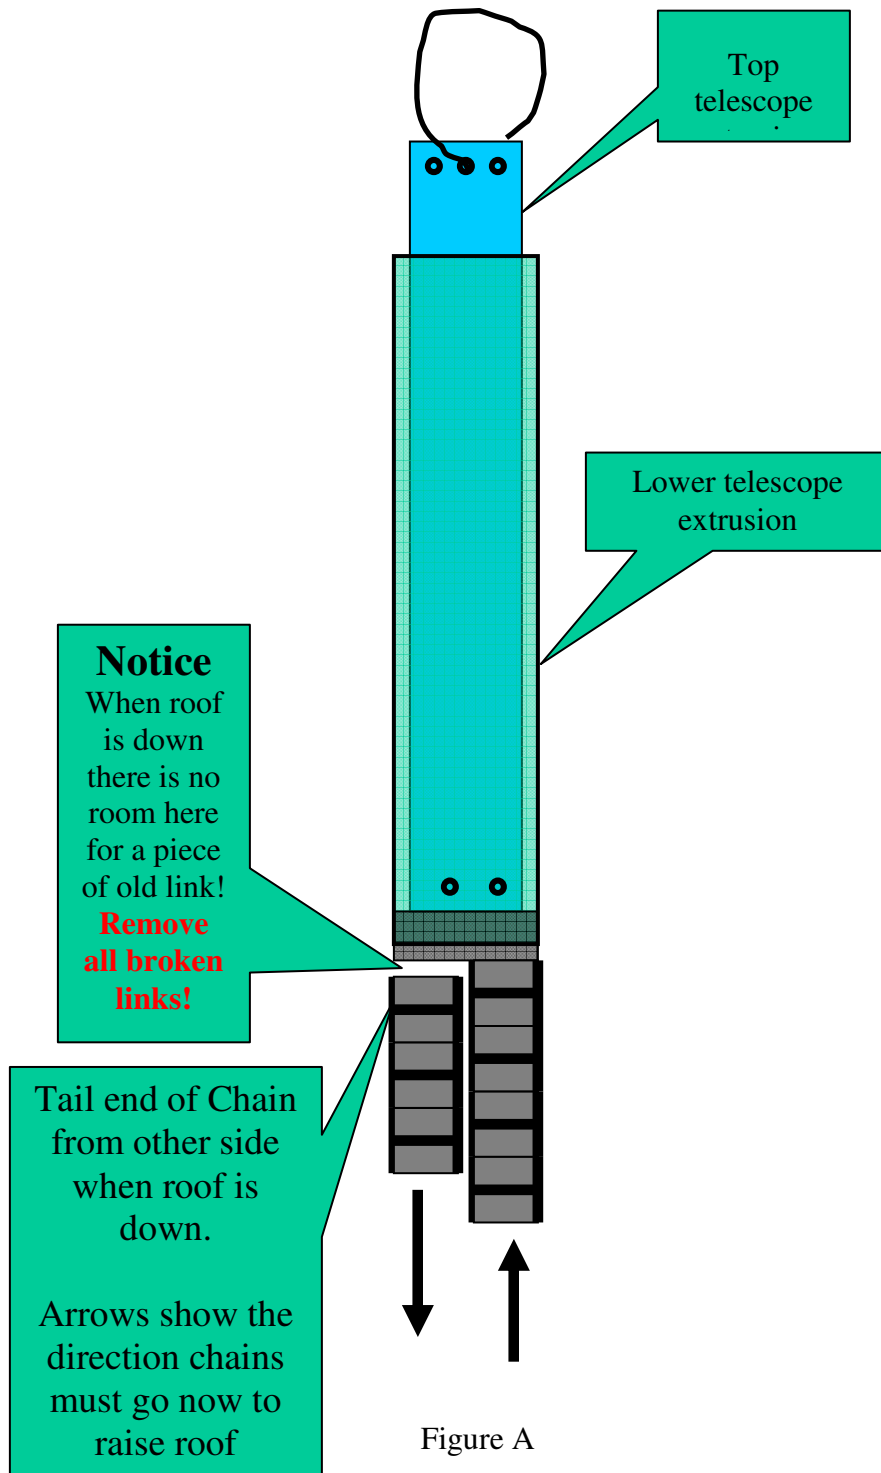
After the telescope extrusion has been detached from the roof anchor, twist the sidewall latch freeing the wall from the telescope extrusion and pull down the telescope extrusion to a good working height. Thread a 3 foot piece of 14/16 gauge wire through the center rivet hole and tie the two ends of the wire securely together forming a big loop of wire that you can pull the telescope extrusion upward later in the procedure. See figure A.

(See figure A as to why there should be nothing but 2 good chains in the track).

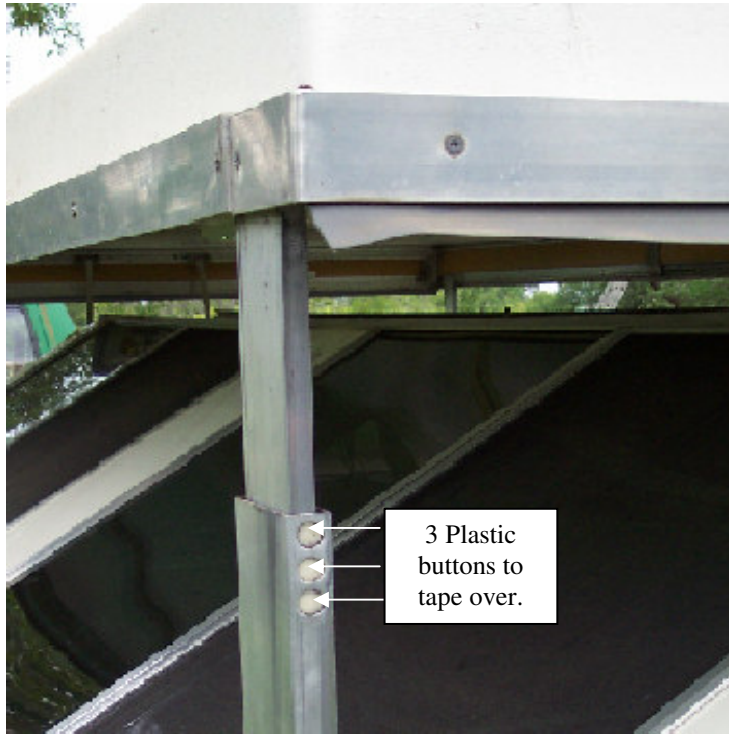
Using the duct tape, tape over the plastic buttons (See above picture) on the side of the lower telescope extrusion, making sure that the tape sticks to the plastic buttons. This will hold the plastic bushings in place when you push the smallest / top telescope extrusion back down into the lower telescope extrusion.

The duct tape helps keep the plastic side bushings in place while you do the next step.

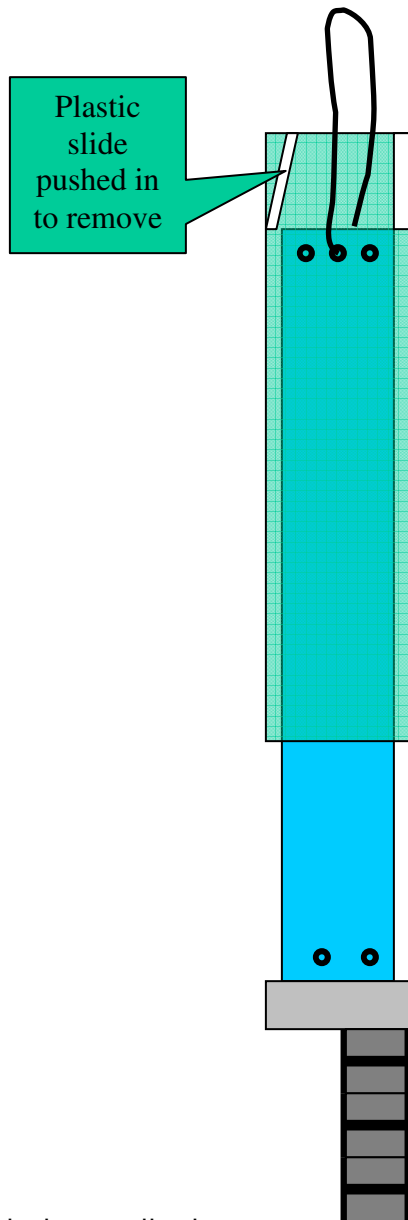
Carefully push the small telescope extrusion into the lower telescope extrusion until it is just below the plastic bushings and then remove the plastic bushings being careful not to drop them down the lower telescope extrusions hole. Fig B

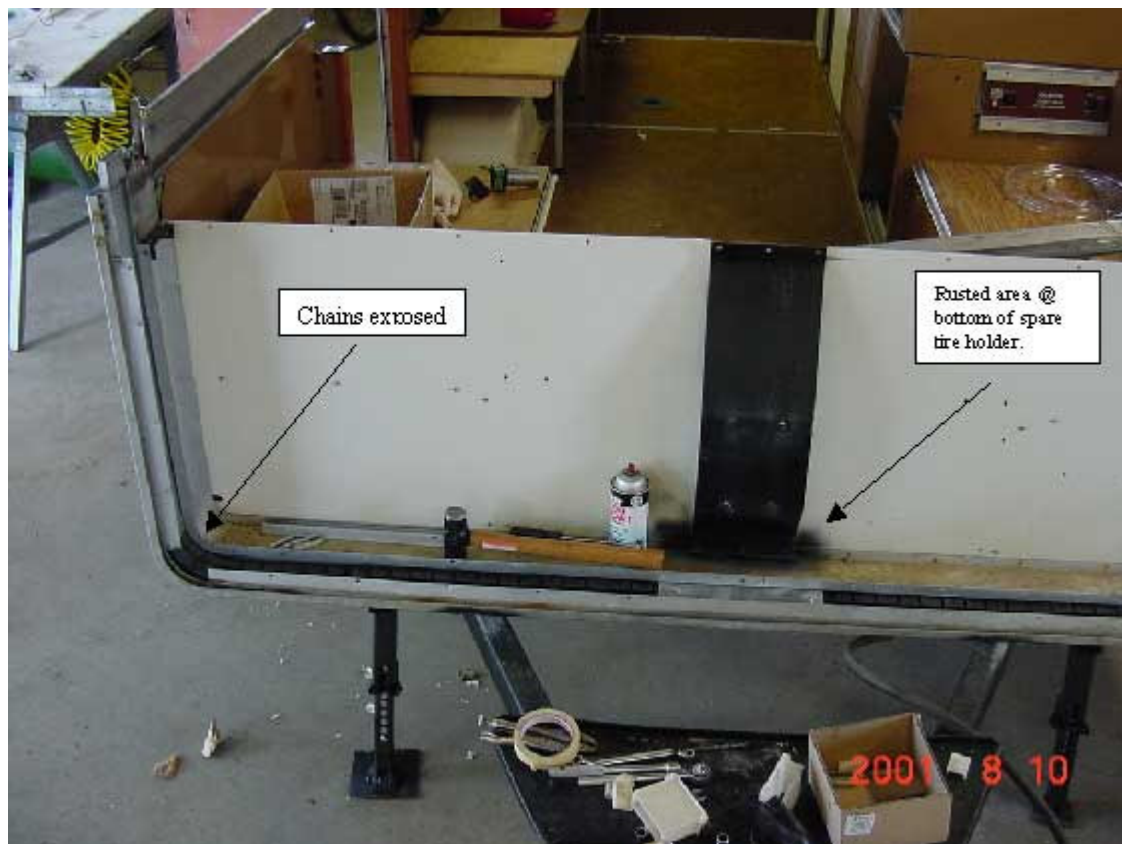
The picture above is just to help you see the inside area that is not normally visible. You will probably never get a chance to see these inner workings of the chain, unless you remove the front bezel of your trailer.

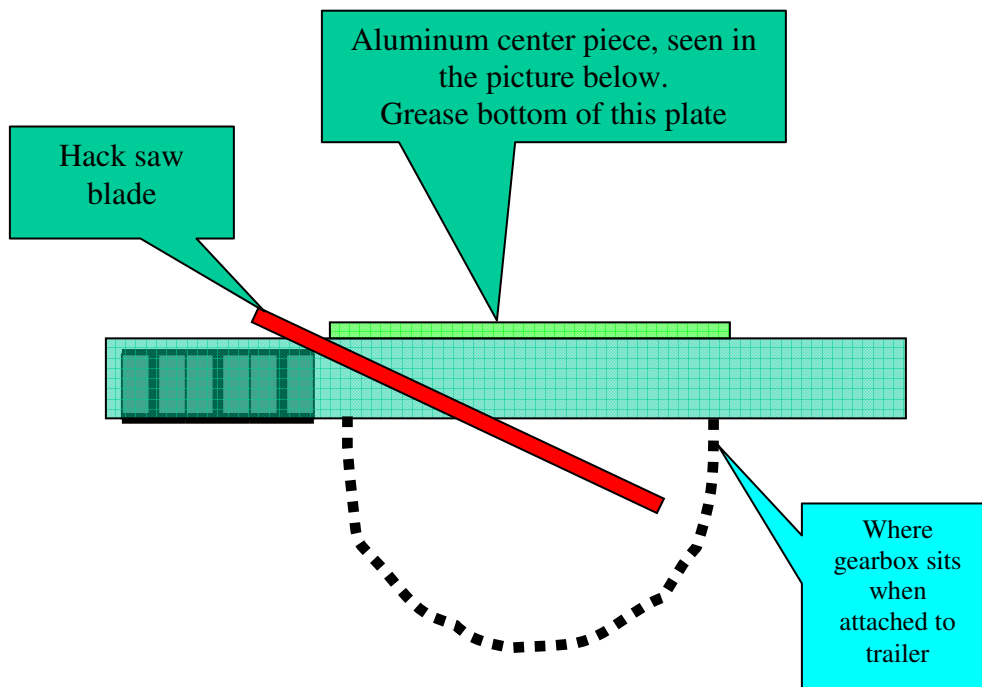
First grease the plate shown in the picture below from the gearbox opening as the chain links get pushed into it from the gears also thoroughly lubricate the chain channel with triflow. For more detail see Lubrication below.

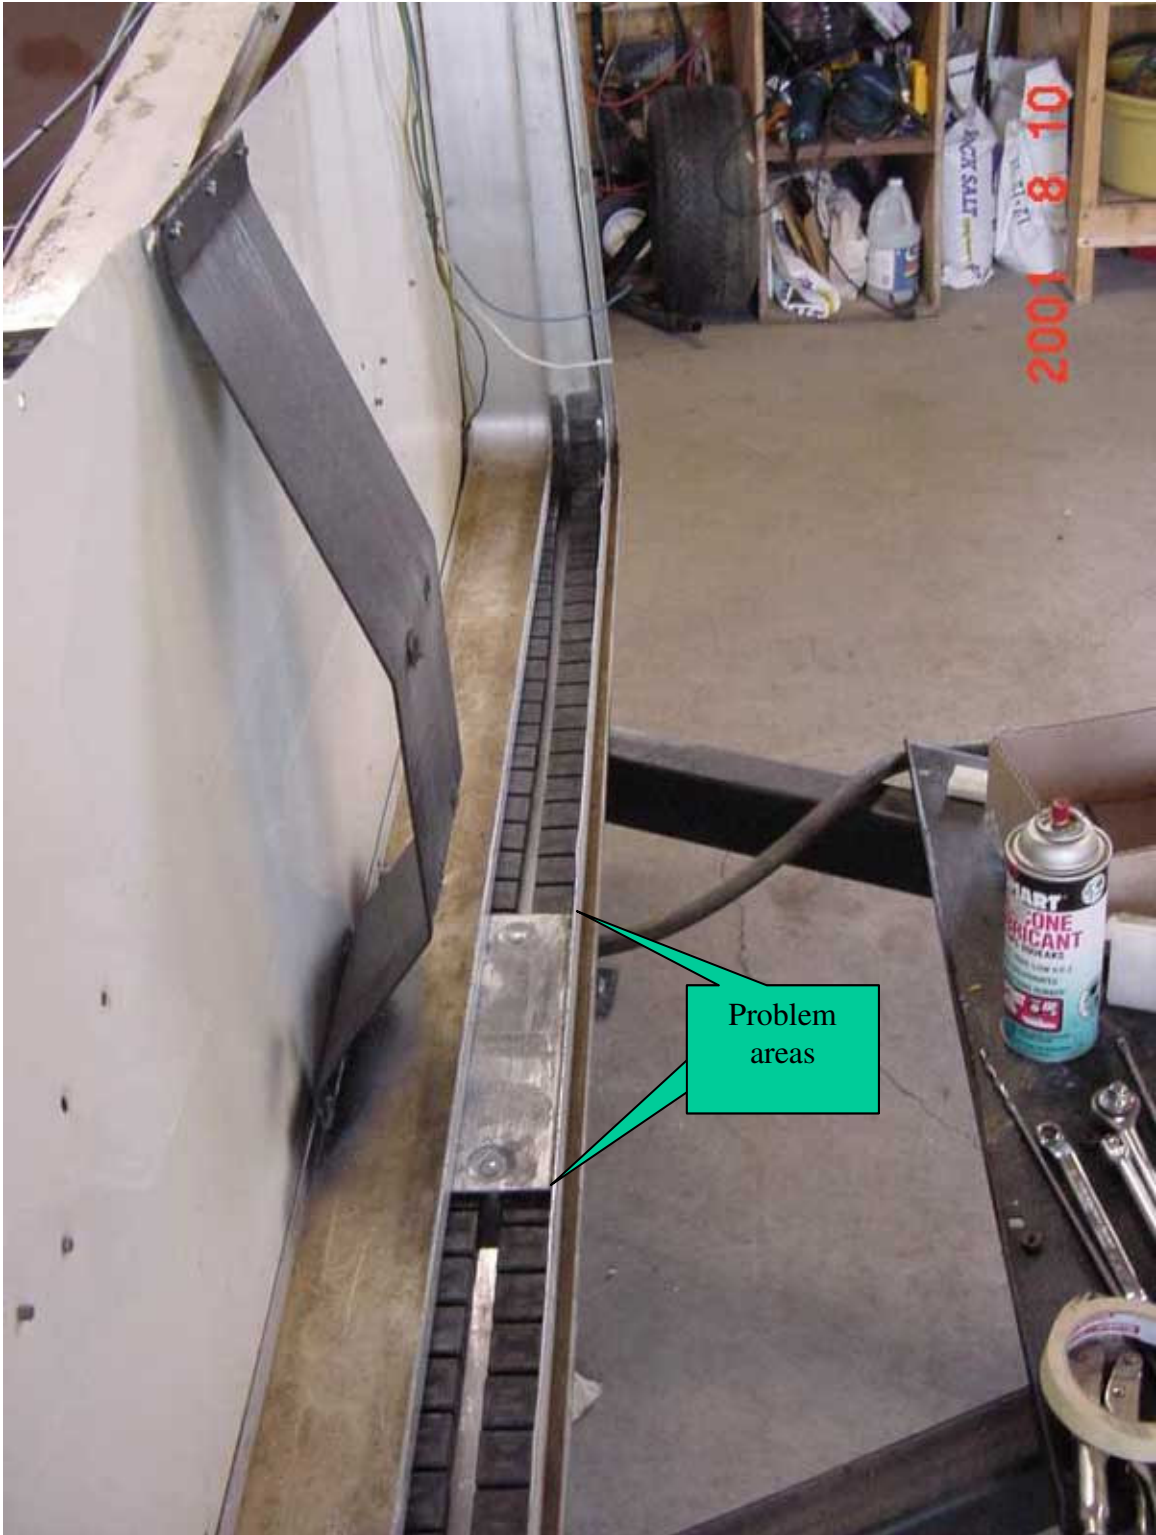
In the picture above note the 2 problem areas that are only a problem when you install chain.

This is a view that you will not see during this chain replacement process.

Now some of the fun begins (My new chains were stiff and didn't want to thread into the lower section very easy. See PG 8). With persistence thread the chains into the lower telescope extrusion all the way down until it stops. At this point there is usually a large amount of chain left outside the lower telescope extrusion, your chain has reached the problem area see photo on the next page below.

The problem arises when you push the chain in the channel to the metal centerpiece that is above the gearbox. The chain being pretty much continuously bent wants to curve up at the leading edge of the chain by $\frac{1}{4}$ inch or so, however it is enough to hit the top piece in the center.

When you reach that point you must take a hack saw blade or long thin flat blade screwdriver and insert it in the gearbox area to force the chain down to the bottom of the track while the second person pushes the top telescope extrusion with chain attached down into the lower telescope extrusion.
